TOWN OF PORTSMOUTH  
ECONOMIC DEVELOPMENT COMMITTEE

Wind Turbine Impact Report

# ***WIND BLADE IMPACT ANALYSIS***

**Subject: Memorandum 2  
WIND BLADE IMPACT ANALYSIS REPORT**

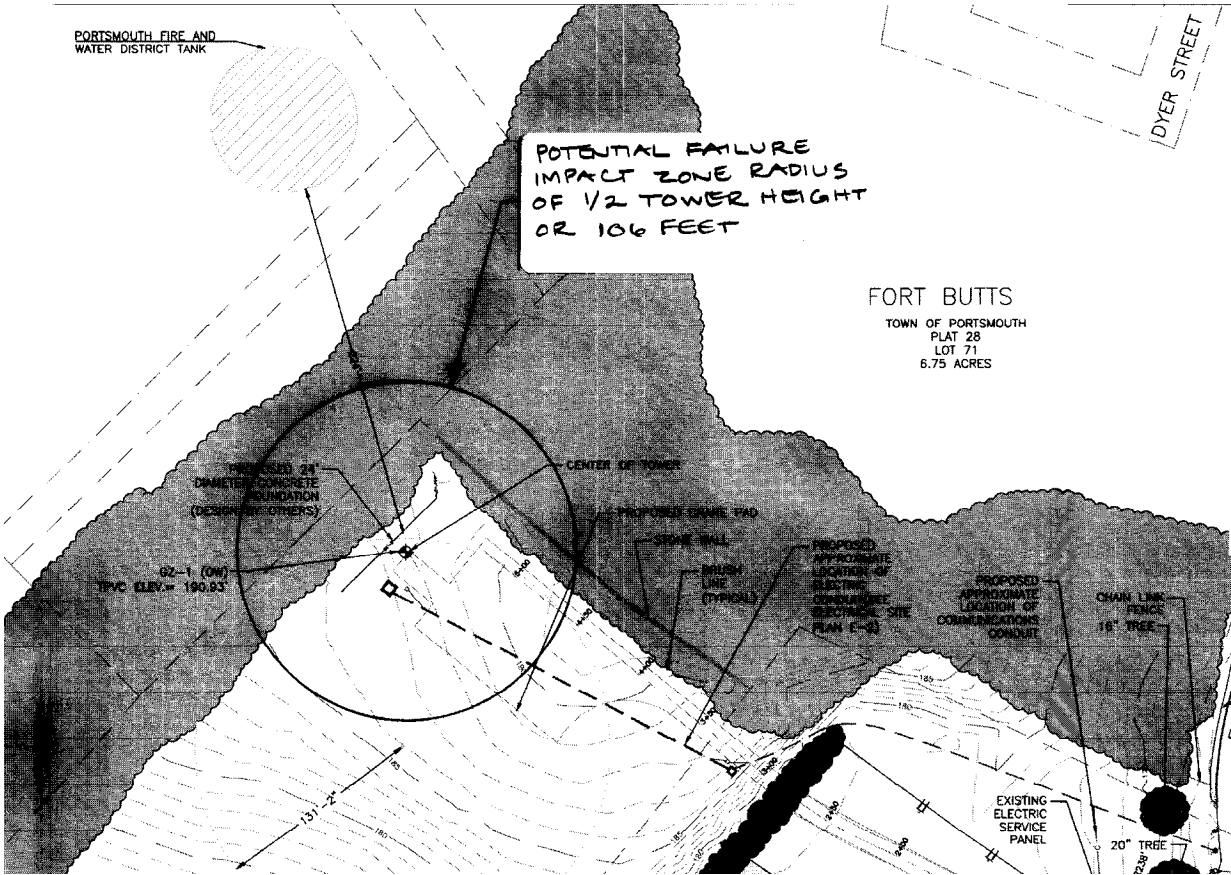
After reviewing the design documents provided on the AAER tower, nacelle, and blades, we have determined that the AAER Wind Tower is predominately safe. Although any of the wind tower failure scenarios are possible, and it is not possible to rule out any of them, the key point of this report is to address what impacts the survivability of the water tank structure. The tower is 244 feet away from the water tank, which is sufficiently far so as any possible scenario of the tower collapsing would not affect the water tank. This is noted on Figure A provided, that if the tower were impacted by a blade during normal operation, it would fail at approximately the mid-height and collapse at a safe distance from the water tank.

the water tank structure is not within striking range of the tower itself, based on the geometric analysis described above and contained in the attached Figure.

**Figure A:** *If the tower is struck by the blade, the potential failure impact zone will be within a radius equal to one half the tower height or 106 feet from the tower.*
